Design and Construction of Creekside Town Center Bridges

Peter A. Giessel, P.E.
Reid Middleton, Inc.

Creekside Town Center Bridges

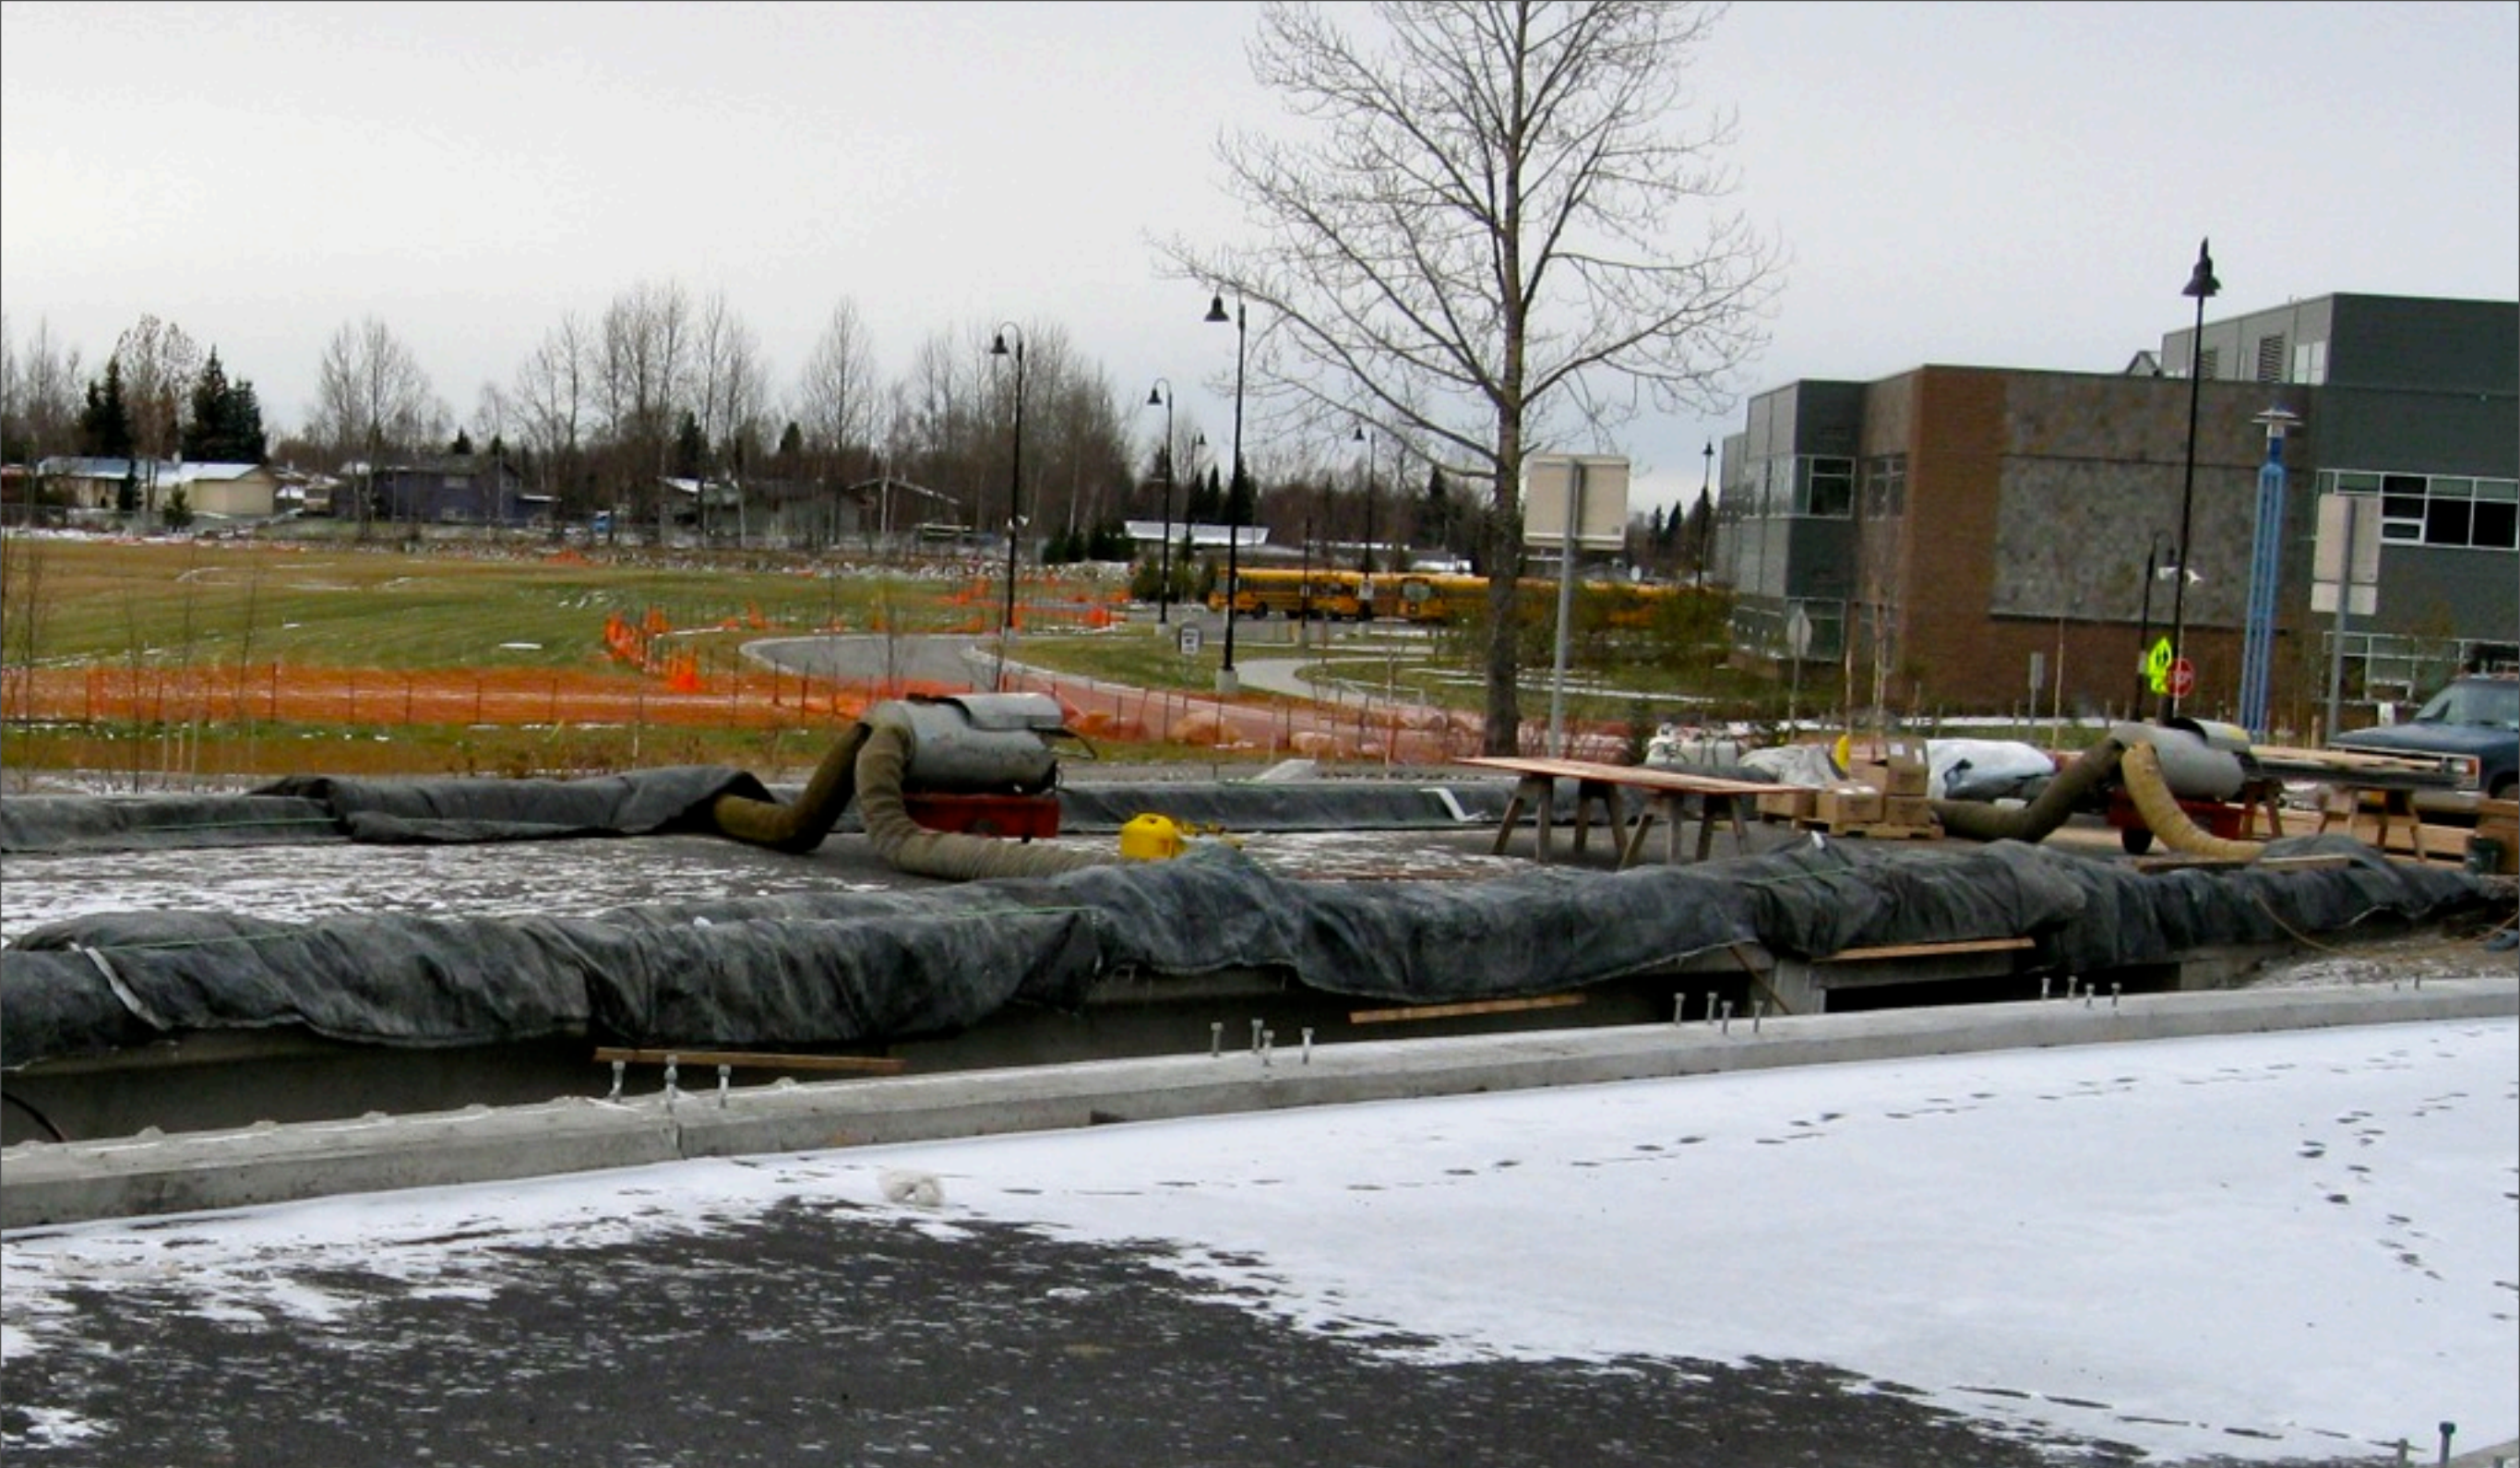
Heating the Curb to
extend the height
